TECHNICAL REPORT ARCSL-TR-78034

A METHOD OF SOFT BODY ARMOR EVALUATION: CARDIAC TESTING

US ARMY ARMAMENT RESEARCH AND DEVELOPMENT COMMAND
Chemical Systems Laboratory
Aberdeen Proving Ground, Maryland 21010

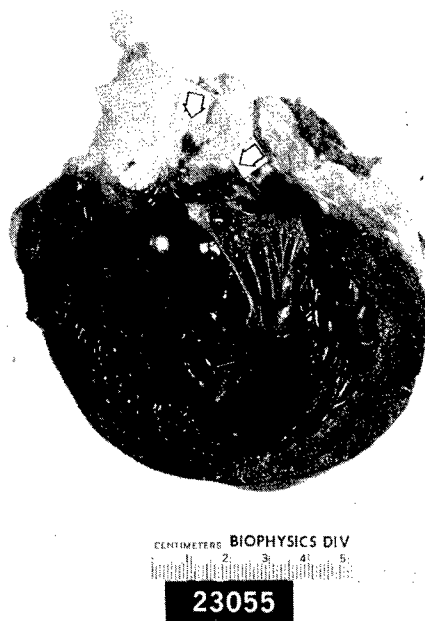
Figure 2. Aortic Lacerations

One animal (54) had no cardiac damage, but this animal experienced injuries to both the aorta and right lung. The aorta exhibited a full-thickness transverse laceration in the ascending portion approximately 3 cm in length. There was a parietal pleural tamponade which prevented massive hemorrhage. A partial-thickness 2-cm transverse laceration of the aorta with intimal disruption also occurred approximately 3 cm from the aortic valve. Examination revealed multiple contusions involving the entire right lung (figures 2 and 3). The velocity of the projectile was 830 ft/sec.

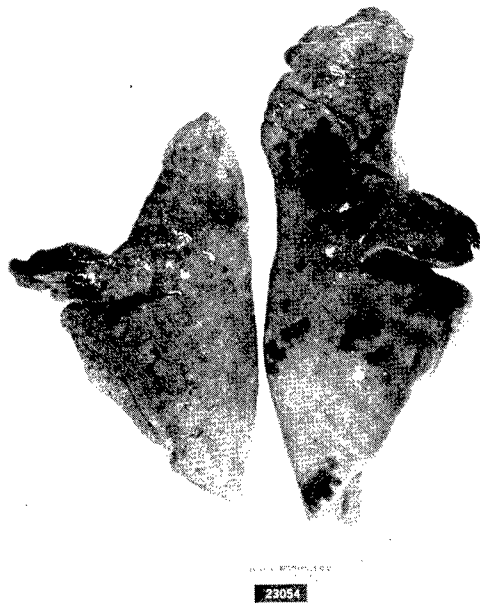
Figure 3. Multiple Pulmonary Contusions, Right Lung

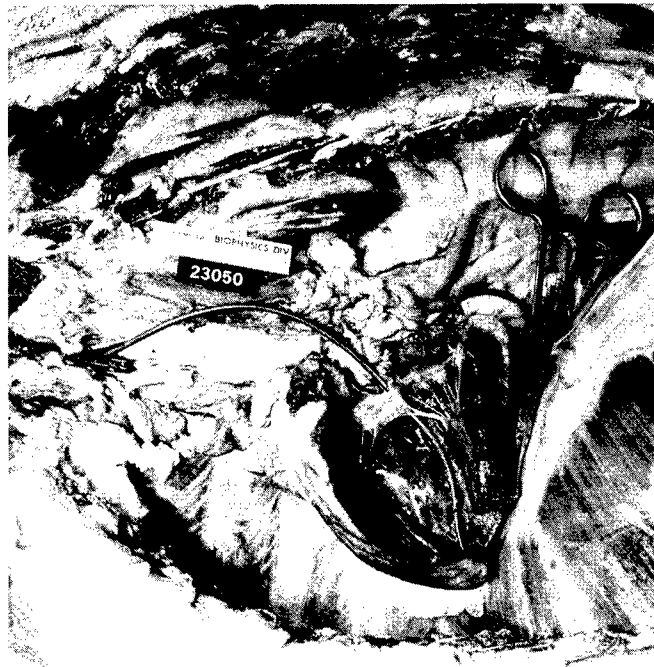
Figure 8. Left-Ventricular End-Diastolic Catheter in Place

In this group of seven animals, a PE No. 230 catheter was placed percutaneously via the left common carotid into the left ventricle to monitor end diastolic pressure. Correct positioning of the catheter was ascertained by recording typical ventricular pressure curves.
